NASA TECHNICAL
MEMORANDUM

NASA TM X-64819

MSFC SKYLAB INSTRUMENTATION AND COMMUNICATION
SYSTEM MISSION EVALUATION

Skylab Program Office

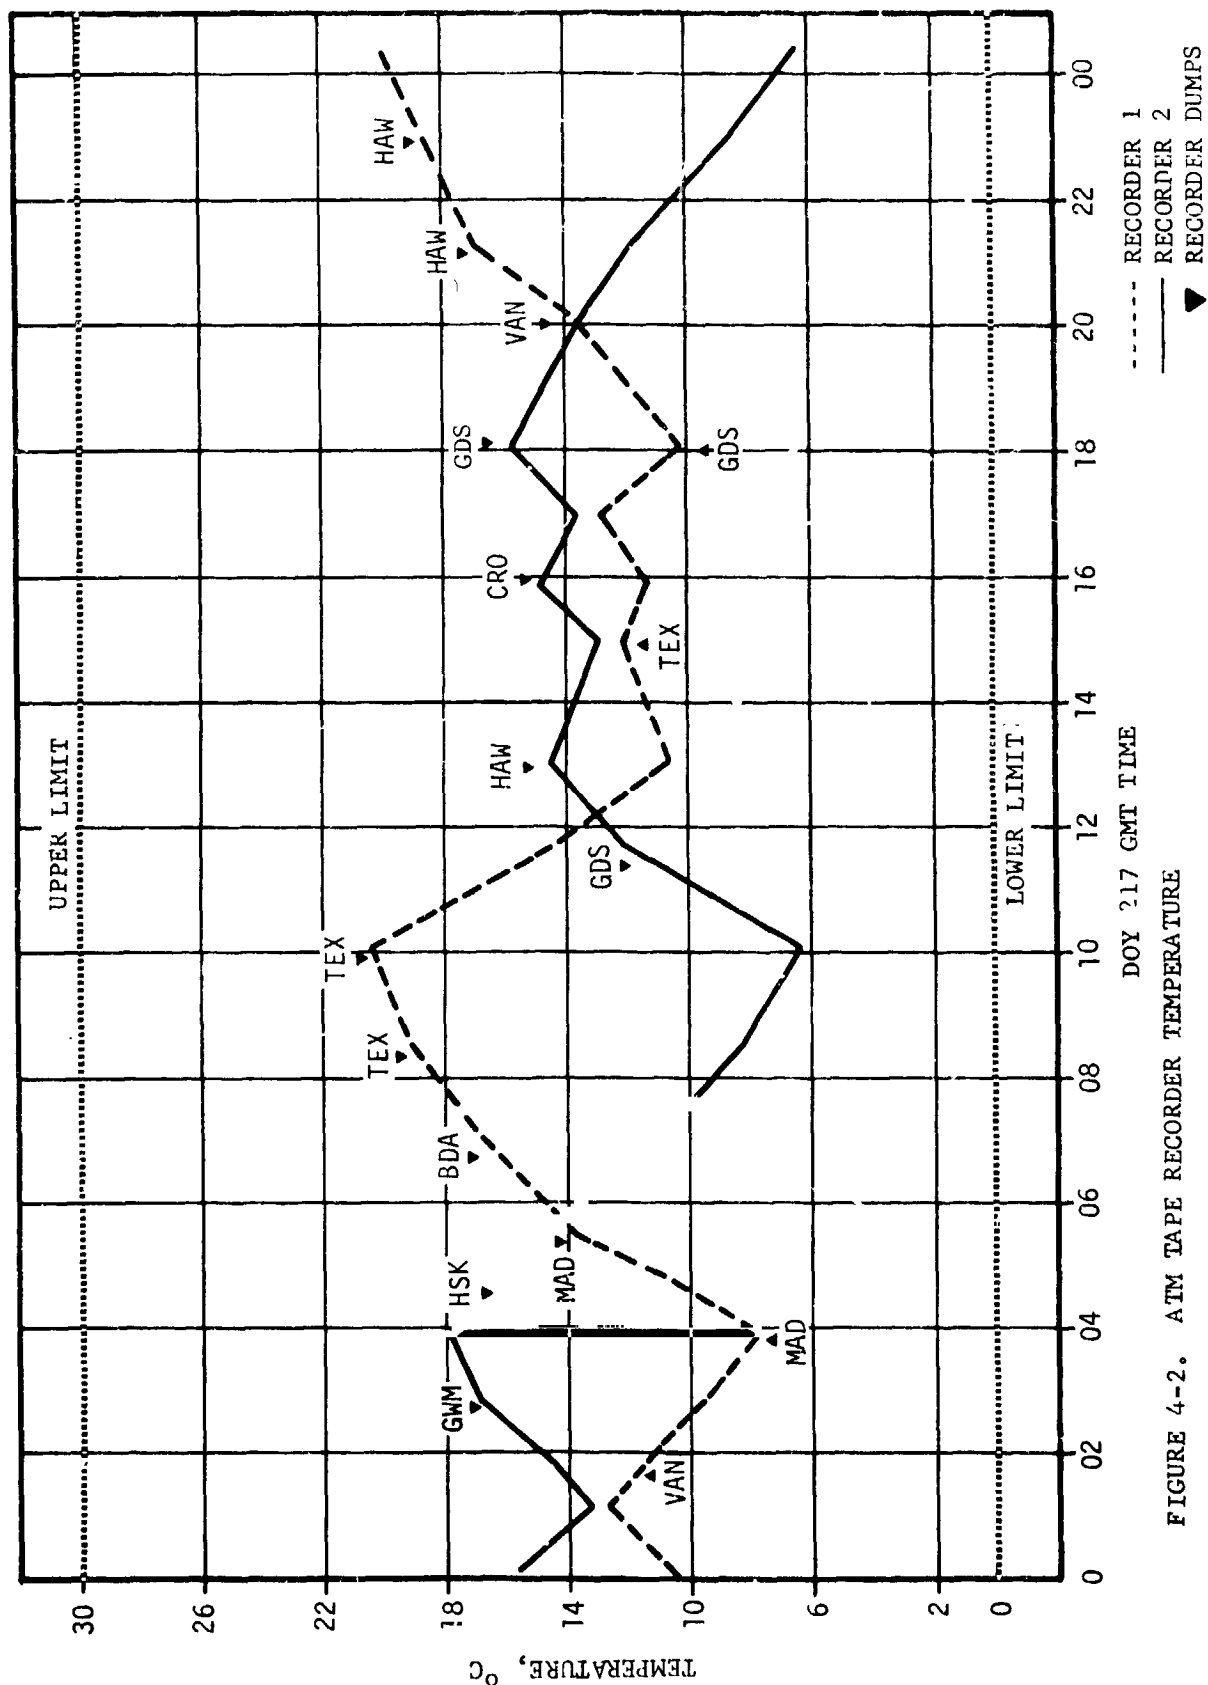
FIGURE 4-2. ATM TAPE RECORDER TEMPERATURE

The loss of the meteoroid shield shortly after launch altered the original plan to run the primary tape recorder continuously during the mission, using the secondary tape recorder as a backup. Thermal stresses on Skylab prompted plotting recorder temperature. It was immediately apparent that continuous operation of a single recorder would cause an over-temperature condition. The management plan was then changed to allow alternate operation of the primary and secondary recorders to maintain recorder operation within the design thermal limits at all times. This plan was in effect throughout the mission. A temperature plot for the typical 24-hour period is shown in Figure 4-2.
